# **Buffalo Fire Department Investigative Report**

*Submitted December 2, 2009*

**3<sup>rd</sup> Alarm Fire  
1815 Genesee Street  
August 24, 2009**

# Investigation of 3<sup>rd</sup> Alarm Fire

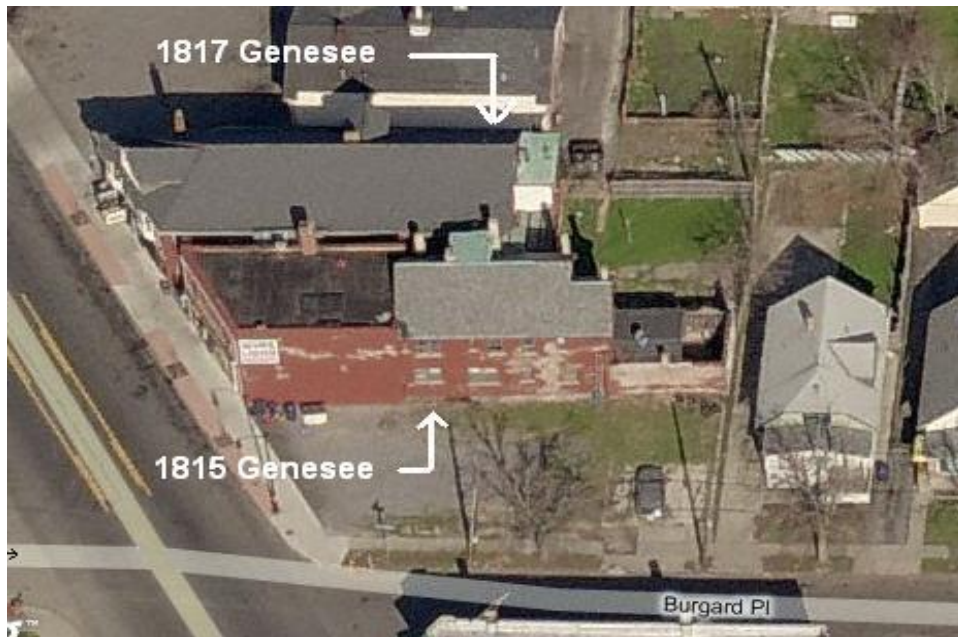
*Overhead of 1817& 1815 Genesee St.*

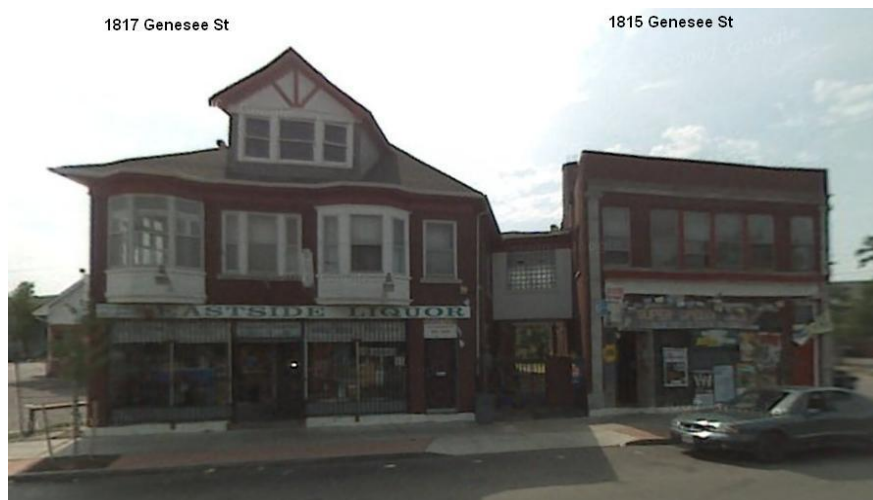
*Front View of 1817(left) & 1815 (right) Genesee St*

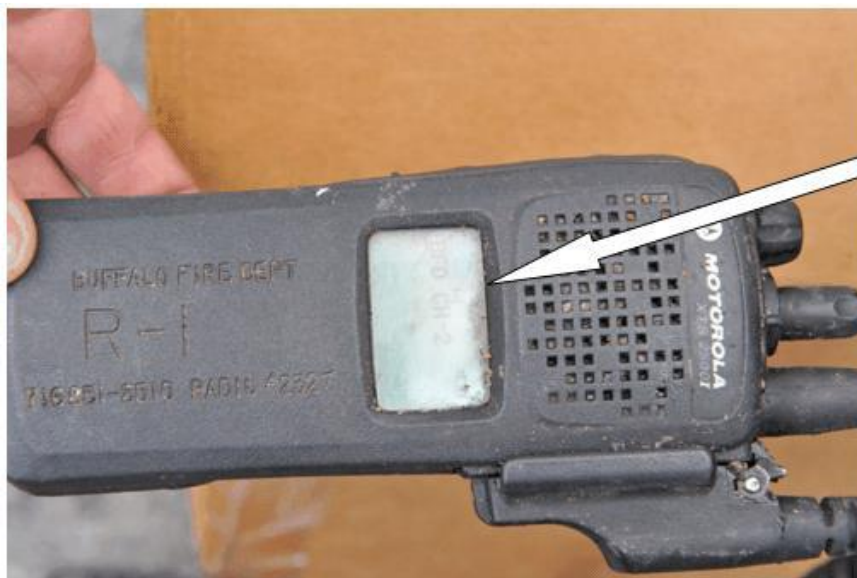
Indicates radio is on Channel 2 (fireground channel) but in "direct" mode. This does not allow transmissions to reach repeaters and limits range to the fireground and nearby station receivers.

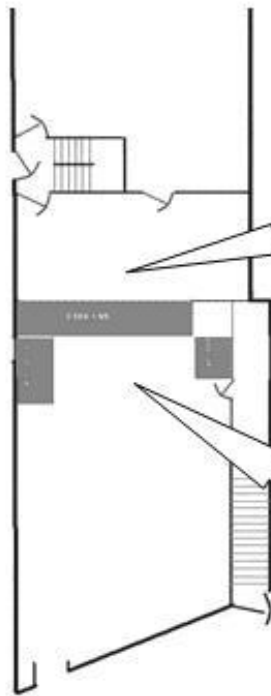
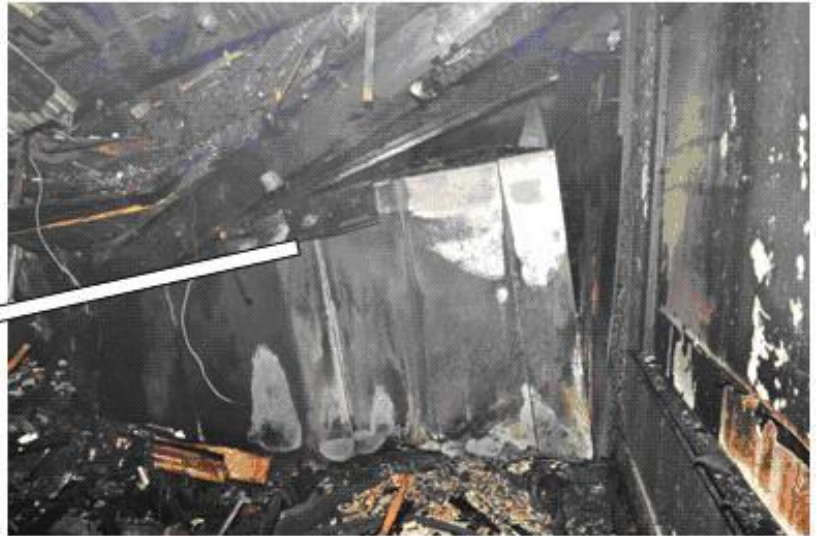
Rear view of store wall coolers.

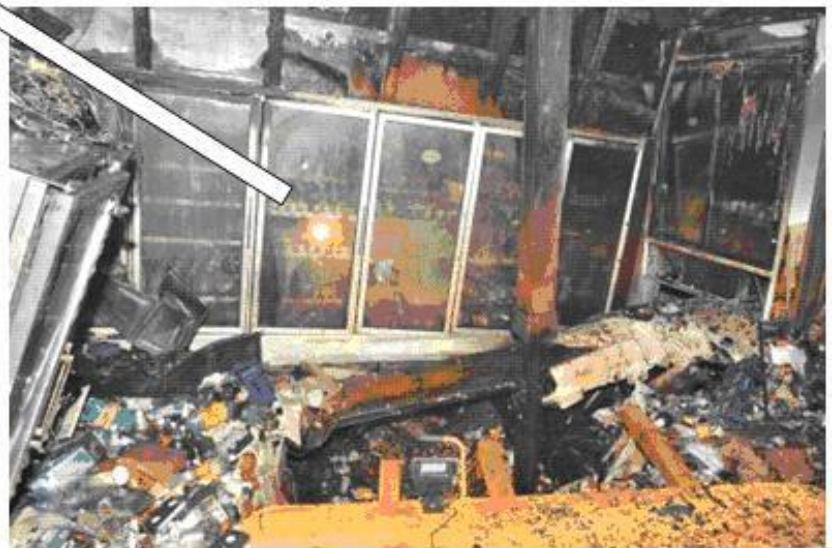
Delicatessen view of rear wall coolers. Note framing above that rose to ceiling, creating a dividing wall between the store and a rear apartment.

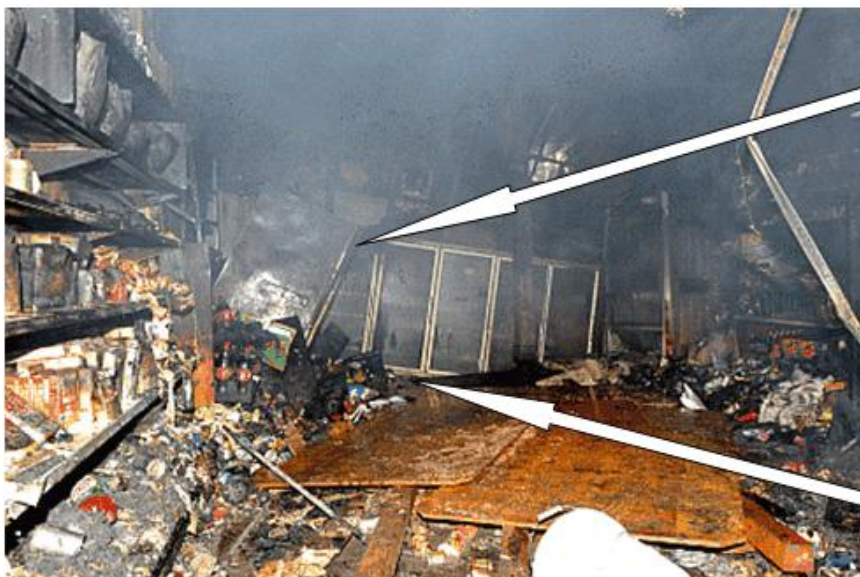
Side cooler: falling into hole and knocking over firefighters as they attempted to reach collapse area.

Edge of collapse area

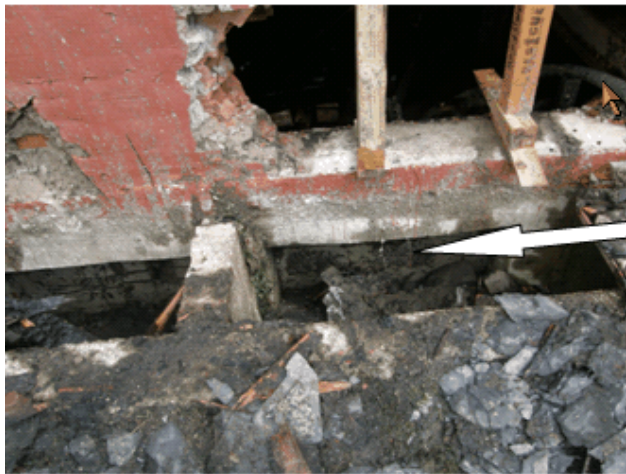
Attempt to breach foundation wall, abandoned due to stability concerns.

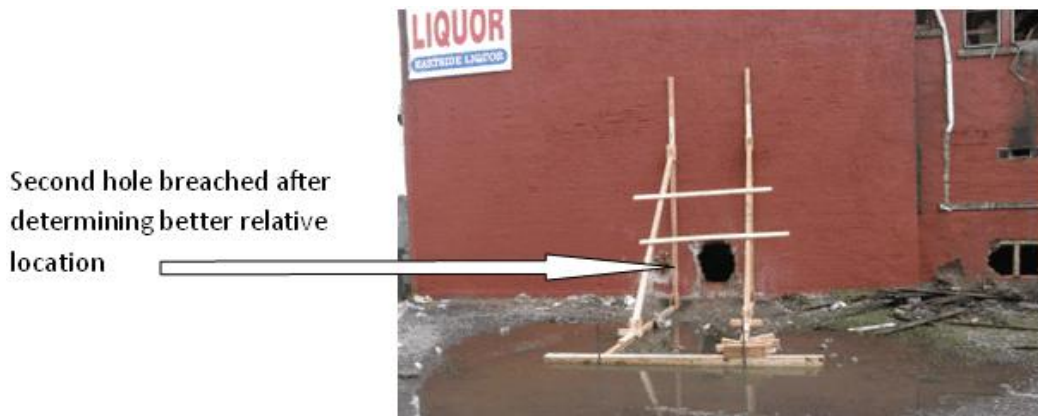
Second hole breached after determining better relative location

Initial breach of foundation and wall

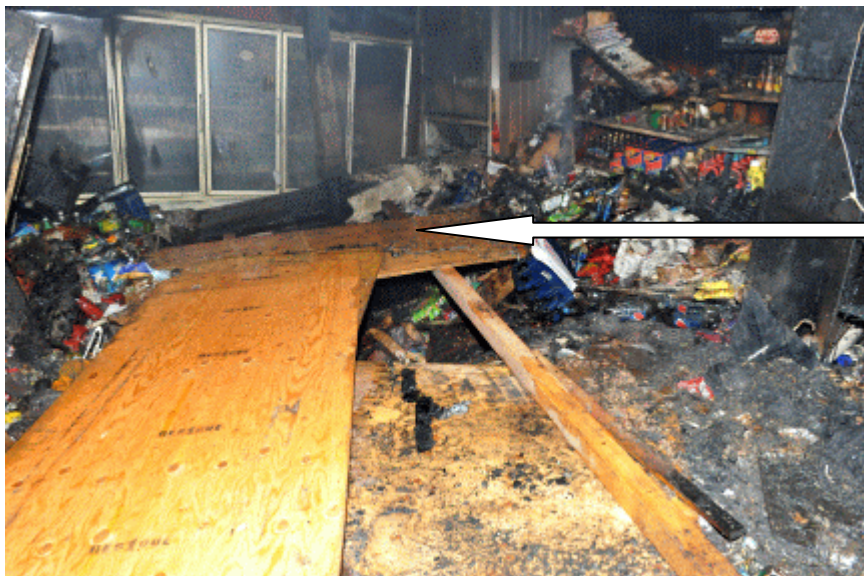
Platform fabricated and used as operating base to access downed firefighters in basement.
